Karehana Bay – WaStop

Customer and stakeholder implications and benefits

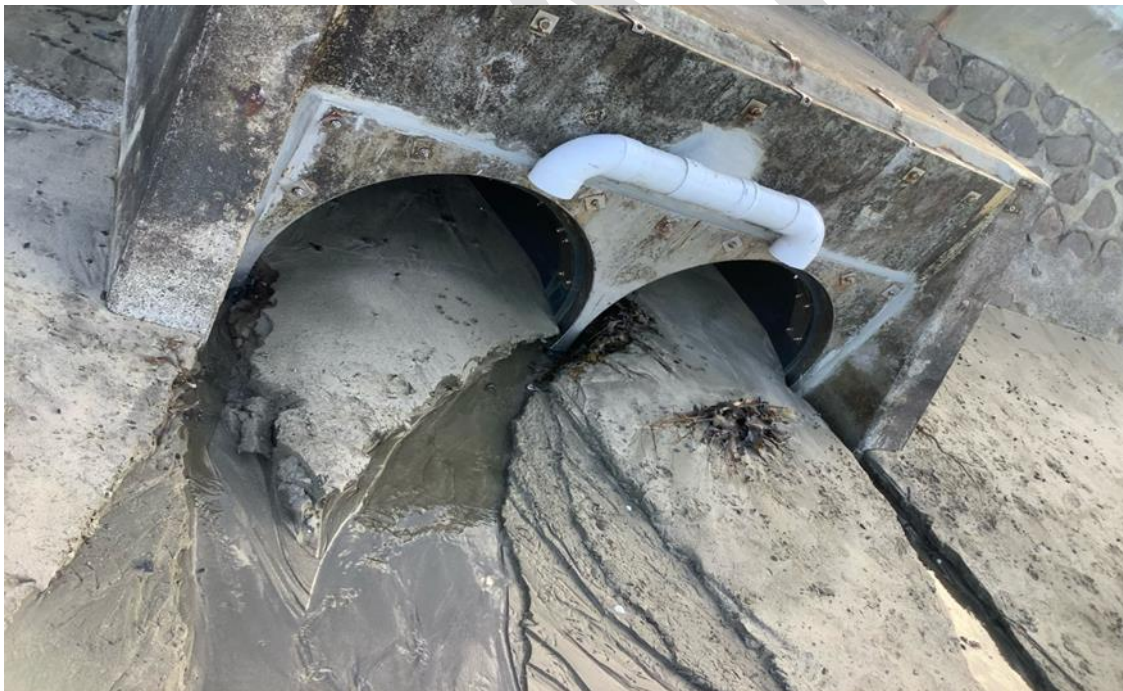
The accumulation of sand inside the WaStop as shown in the photo below requires additional head (hydraulic pressure, higher water levels in Karehana Park) to open the valve.

If the WaStop is removed, then sand is expected to migrate upstream into the pipe and settle to a considerable distance along the pipe due to its low gradient and tide levels. The outlet pipes are completely submerged in high tide. The accumulated sand in the pipe will impede flood flows and can result in higher flood levels in Karehana Park during storm events. The impact of removing the wastop and allowing the sand to buildup in the stormwater main is not fully understood. It is expected that sand will be mobilised with storm flows and would be scoured rapidly but the pipe capacity would be initially affected due to loss of flow area. The scouring of sand will also depend on how well it binds and becomes

Based on the information gathered to date and advantages and disadvantages of a WaStop it is recommended that Wellington Water can consider the two options outlined below and endorses a preferred option:

Option 1 – Remove the Wastops and monitor sand buildup in the main

This option will involve a short duration trial of removing the Wastop(s) (either one or both) and monitor the sand levels and its extent in the stormwater main. This will involve measuring the sand depths at several key locations along the stormwater main including the outlet, manhole in the footpath along Sunset Parade, at bifurcation point and the manhole along 1500mm diameter main in Airlie Road opposite 54 Sunset Parade (refer to network plan below for areas of monitoring).

Option 2 – Do not remove the Wastops

That the committee considers the two options (Remove the Wastops and monitor sand buildup in the main or do not remove the Wastops but rely on previous operational experience) outlined in this report and endorse a preferred option.

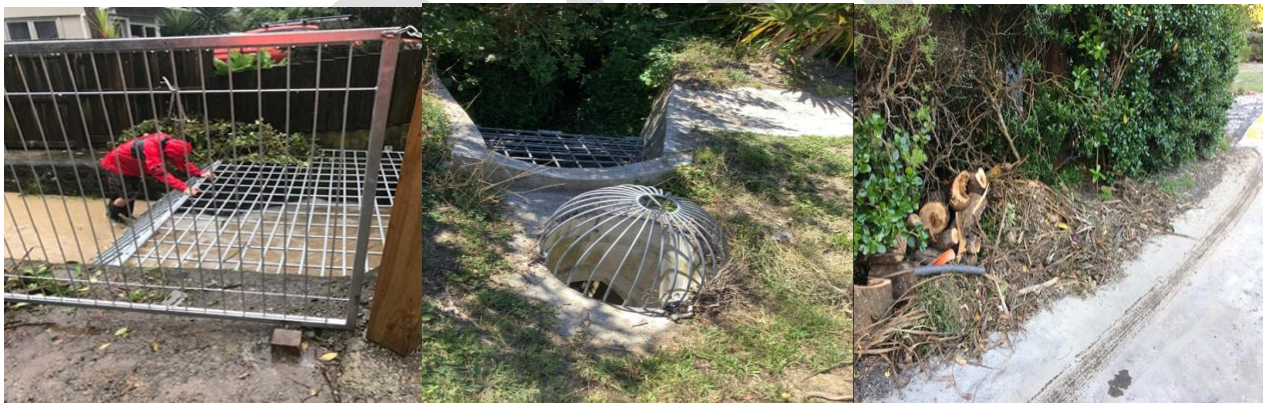
The design of these intake screens means that manual cleaning of these intakes during an event is a safety risk and unadvisable. Our hydraulic model suggests that for 29 November 2020 high intensity rainfall over a very short period there was nearly 8m³/s coming into the Karehana basin, with the capability of the network to discharge only 4.8m³/s. Some residents have tried to clean the screens during flood events without Wellington Water permission and/or appropriate equipment and training and therefore are at potential health and safety risk.

1. Screen design – the existing design is hydraulically inefficient and can result in debris blocking the pipe entry resulting in increased flooding. Key factors to consider in design are bar type

(rectangular is preferred), bar spacing and angle. Horizontal cross bars should be minimized to avoid debris accumulation.

2. Intake structure platform for cleaning can present a health and safety risk to those clearing the screens especially during flood event. Consider the platform type and its dimensions and any fall prevention measures.
3. There is no clear signage to prevent the public from entering and undertaking high risk debris and rock clearance works during flood events at the intakes. Consider appropriate signage requirements to keep untrained and unauthorized persons from undertaking debris clearing works.

It is recommended that the design of these screens is reviewed and where appropriate they are upgraded to meet the current standards and practices. The Karehana catchment stormwater improvements project presents the opportunity to incorporate this work in the design of long-term solutions and is included in the project brief.

That the Karehana catchment stormwater intakes screen design is reviewed as part of the catchment stormwater improvement project to ensure they meet current day standards and safety requirements.
